STUDY OF PIPING FAILURES
AND EROSION DAMAGE FROM RAIN IN
CLAY DAMS IN OKLAHOMA AND MISSISSIPPI

JAMES L. SHERARD
Consulting Engineer
March 1972

Report Prepared for
U. S. Department of Agriculture
Soil Conservation Service

March 15, 1972

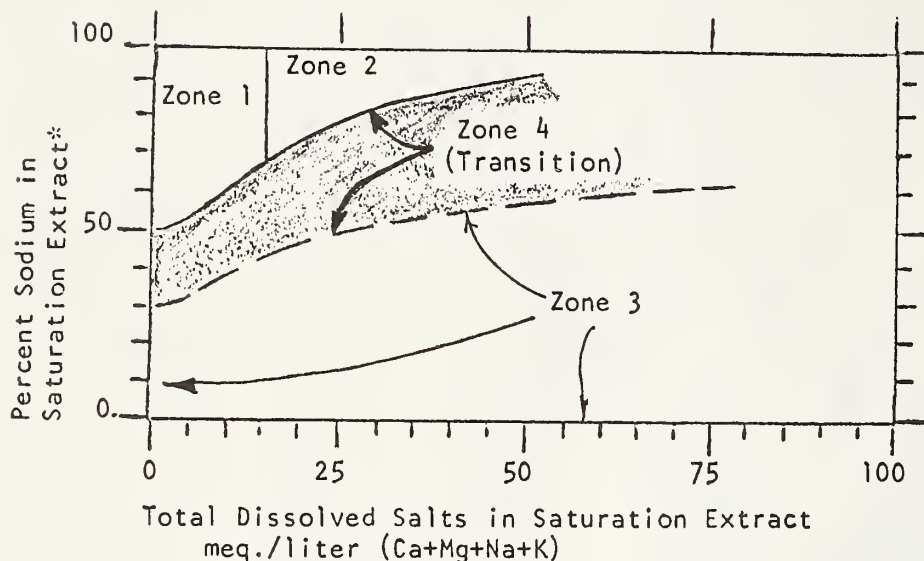
SUMMARY OF CORRELATION BETWEEN CHEMICAL TEST RESULTS AND DAM PERFORMANCE EXPERIENCE

Zones 1 and 2 include nearly all of the clay samples from dams which failed by breaching in Oklahoma and Mississippi. Samples generally have high dispersion when tested in the laboratory. Highly erodible clays.

Zone 1 includes all samples from 16 clay dams which were damaged by tunnel erosion from rainfall in Venezuela, Oklahoma, Mississippi, Arkansas, Tennessee and Texas.

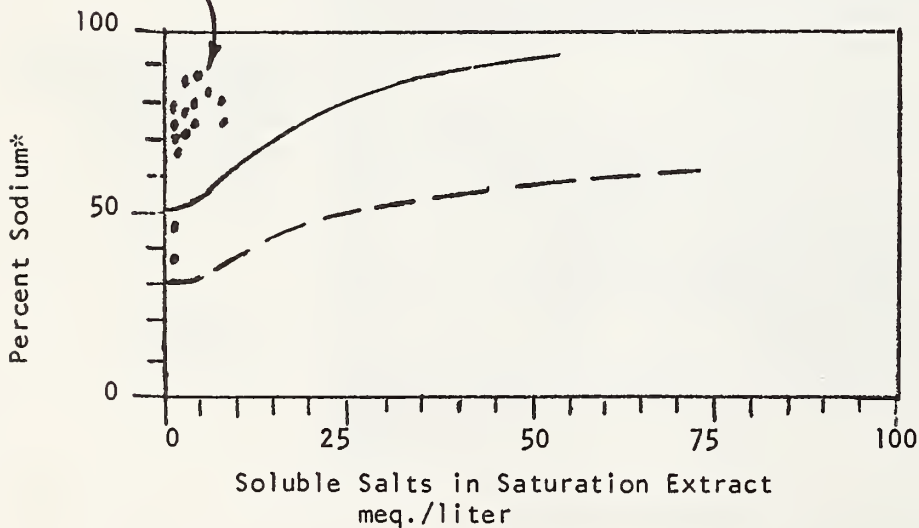
Big Sand Creek Site 8, Mississippi, was badly damaged by rainfall erosion tunnels. Many tests on samples taken and tested at two different times.

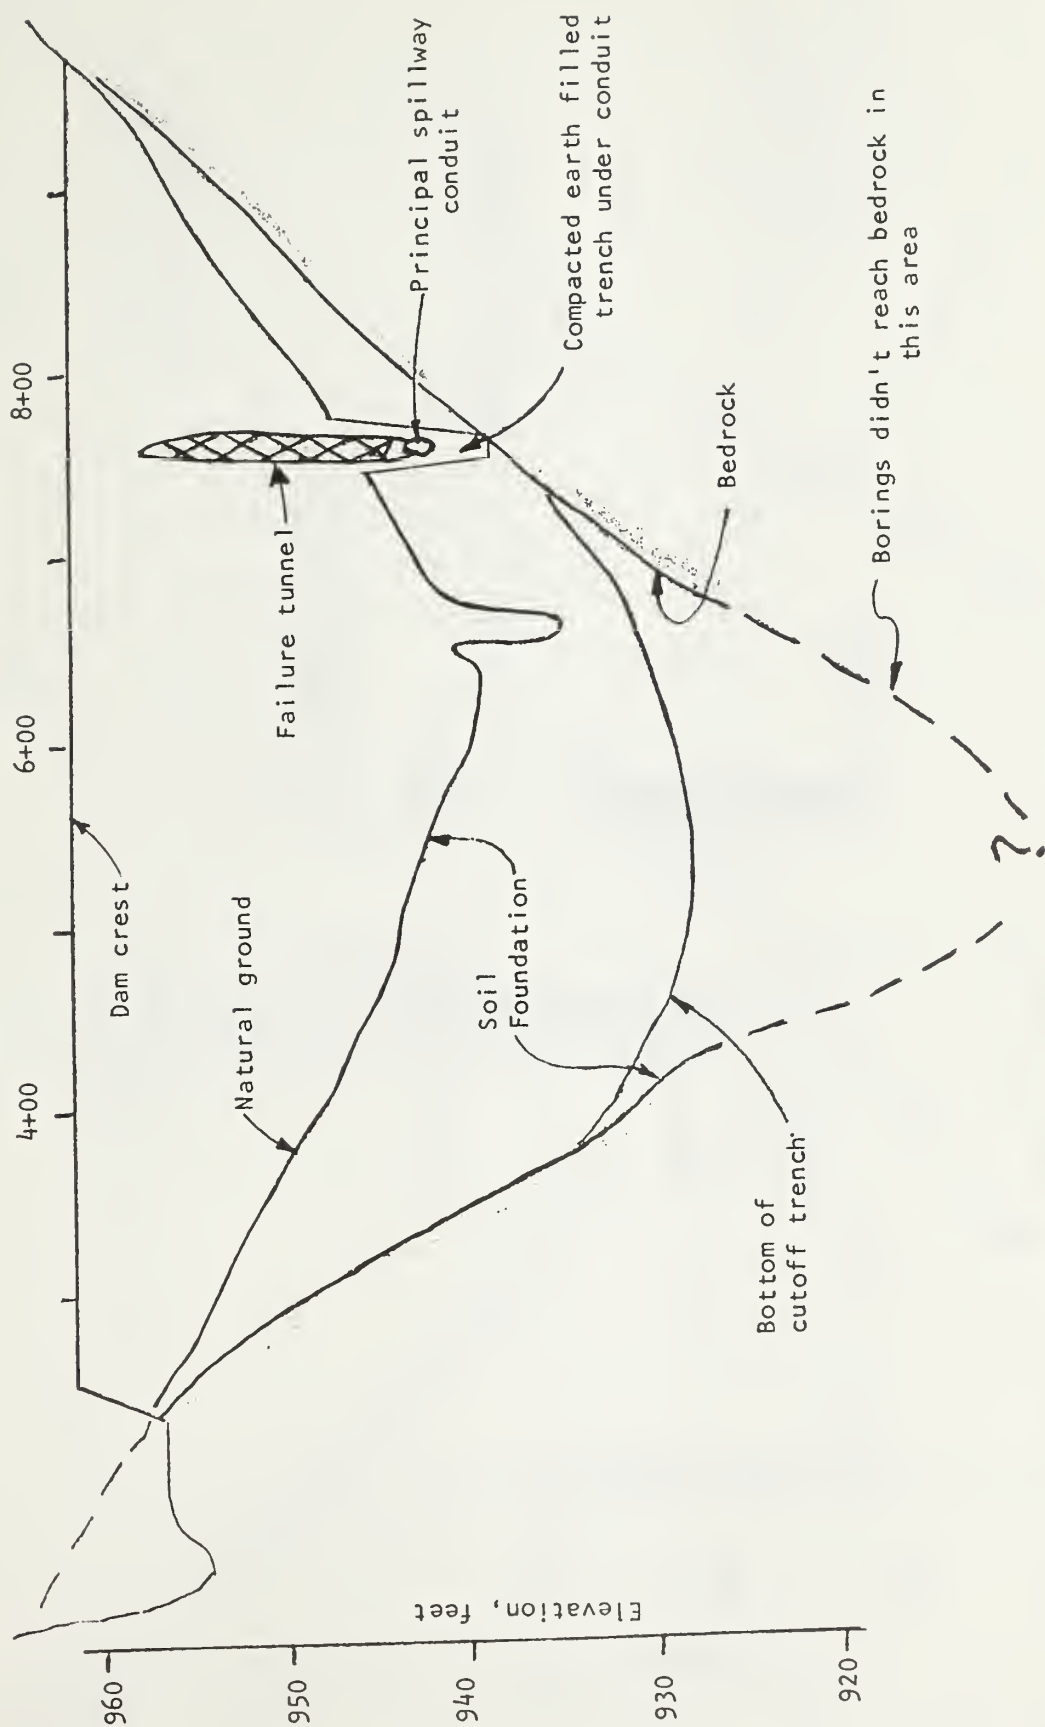
Owl Creek Site 7
 (Longitudinal section
 looking downstream)

The first two of the eleven failures (Owl Creek Sites 7 and 13) occurred May 17, 1957 during the same storm. The other failures occurred at periodic intervals thereafter without any discernible pattern, the most recent being November 1970 (Upper Clear Boggy Site 50).

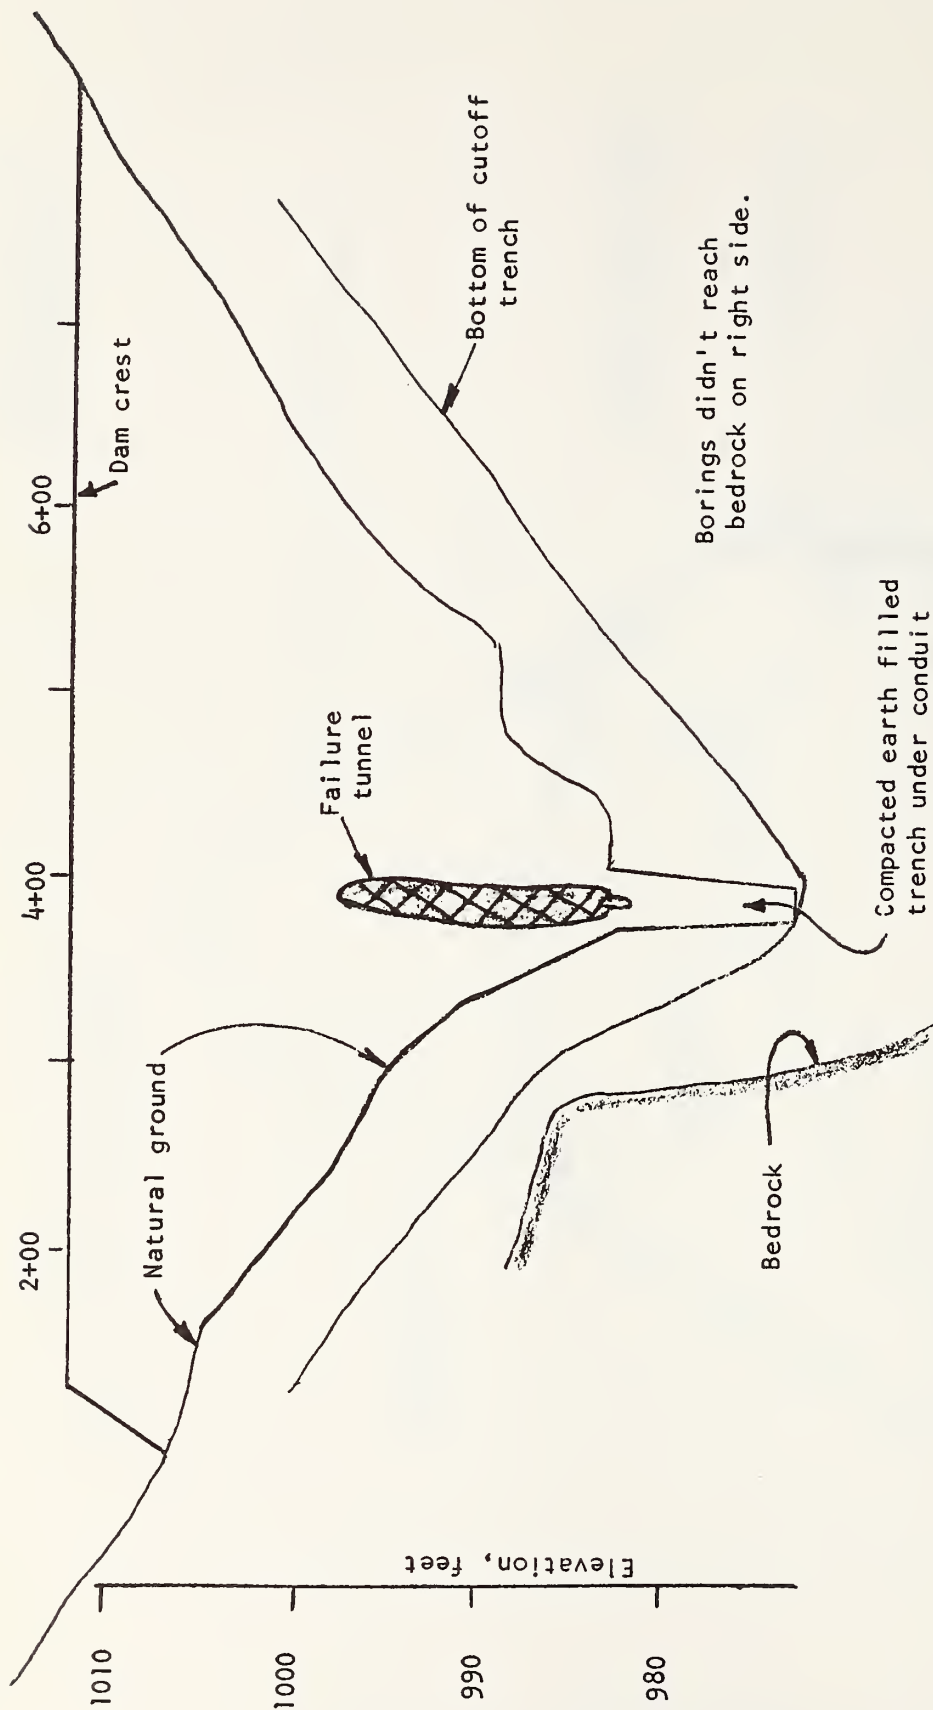
Owl Creek Site 13
(Longitudinal section
looking downstream)

Borings didn't reach bedrock on right side.

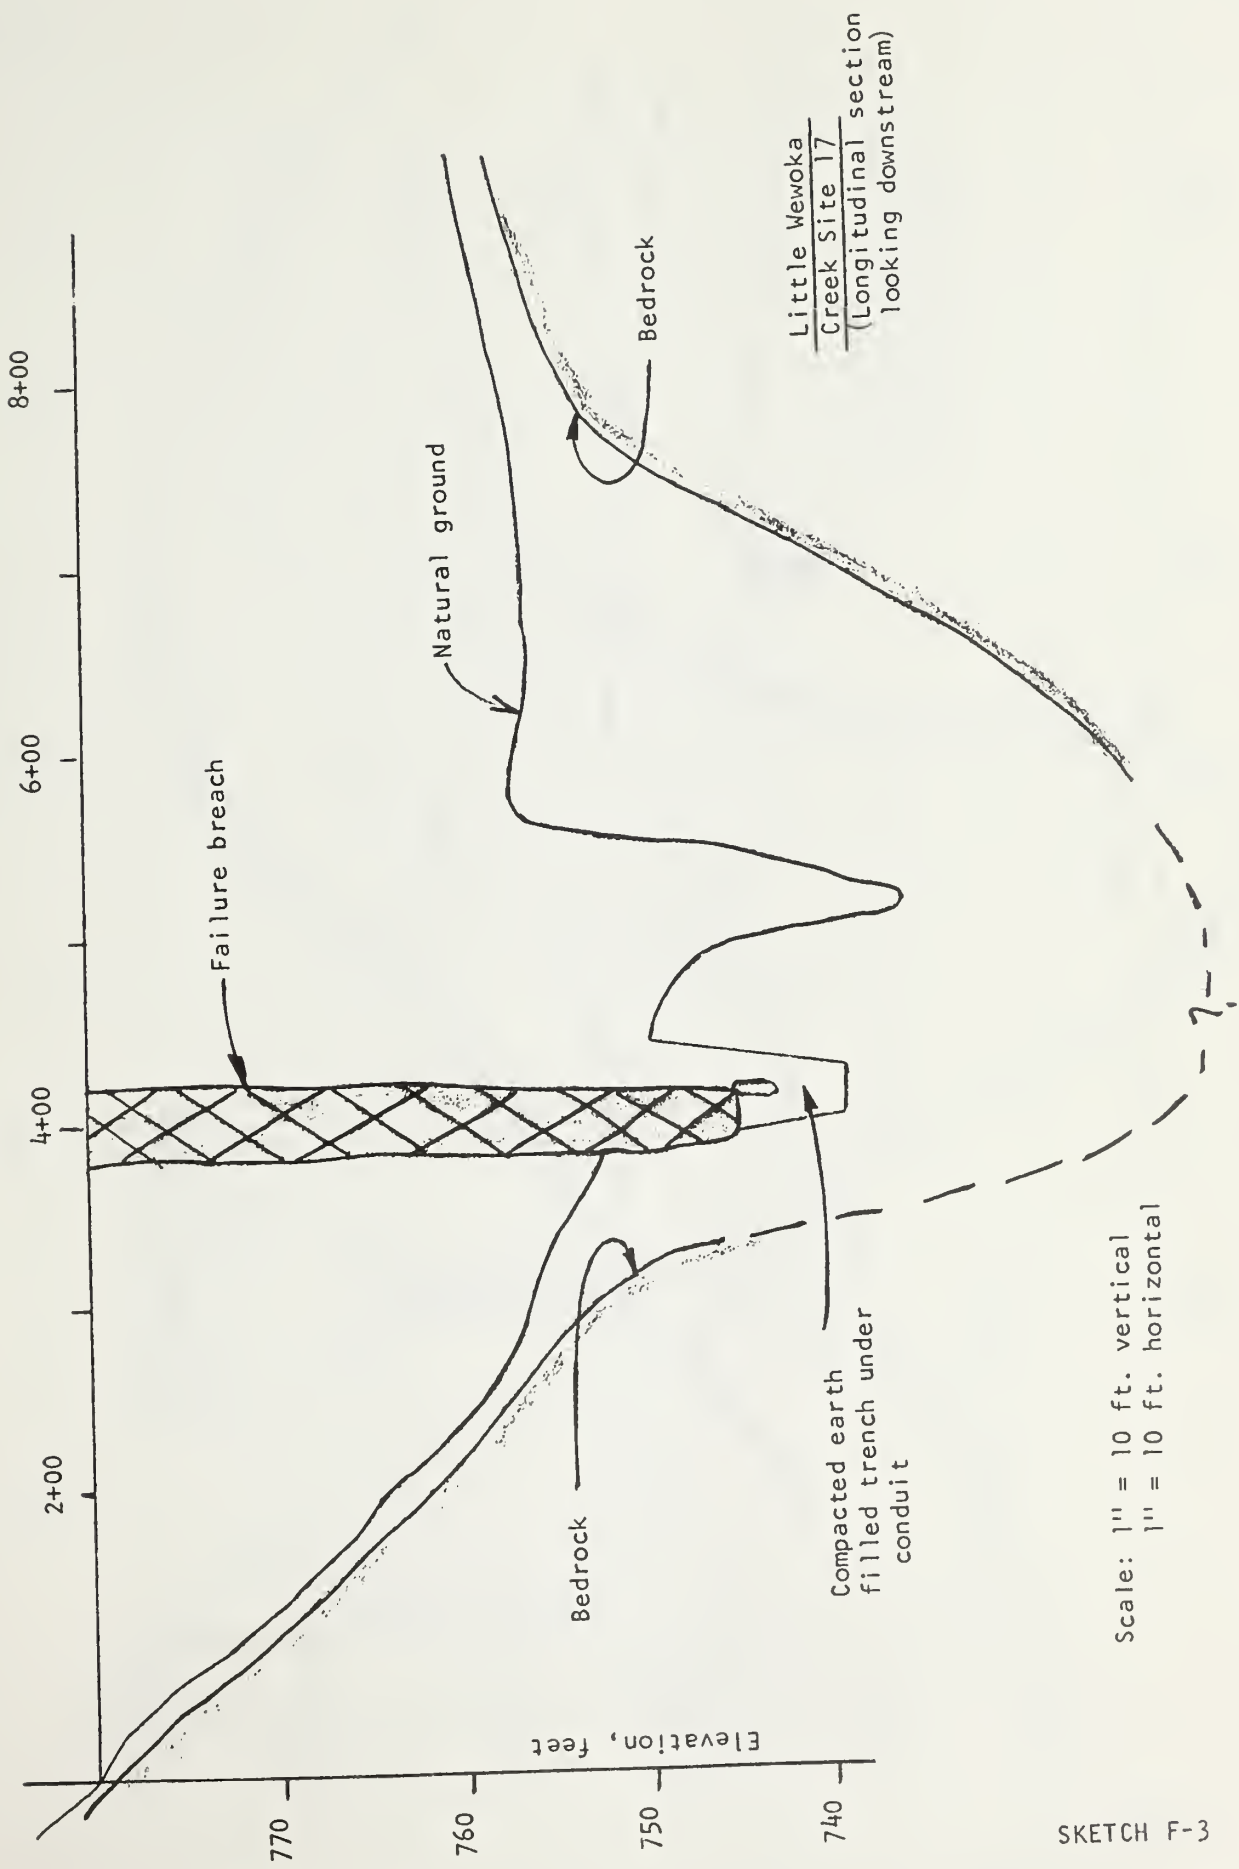
Little Wewoka
 Creek Site 17
 (Longitudinal section
 looking downstream)

3. In the case of Little Wewoka Creek Site 17, where an eye-witness was present to observe the events from the initial development of the leak, it was clear that the leak started through the embankment at about mid-height and then gradually eroded downward to expose the conduit, so that it is well known that the initial leak did not develop along the

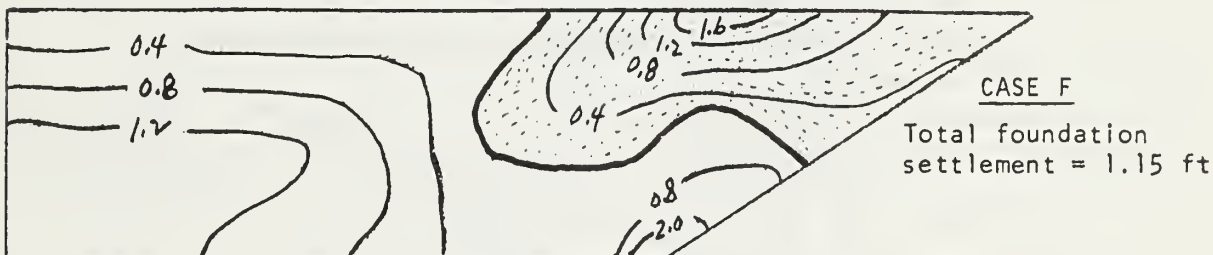
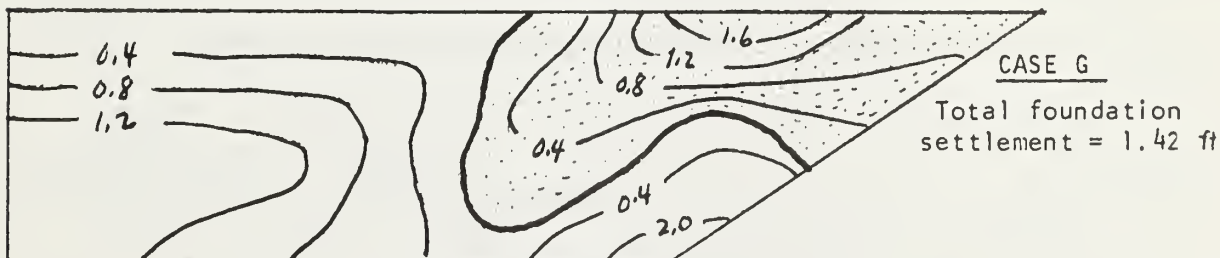
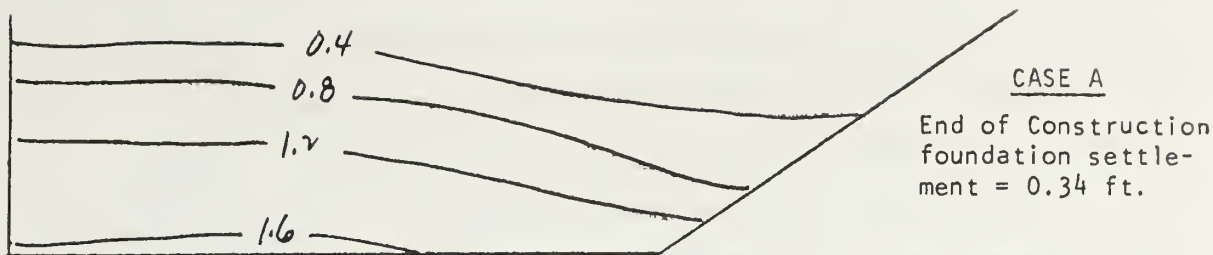
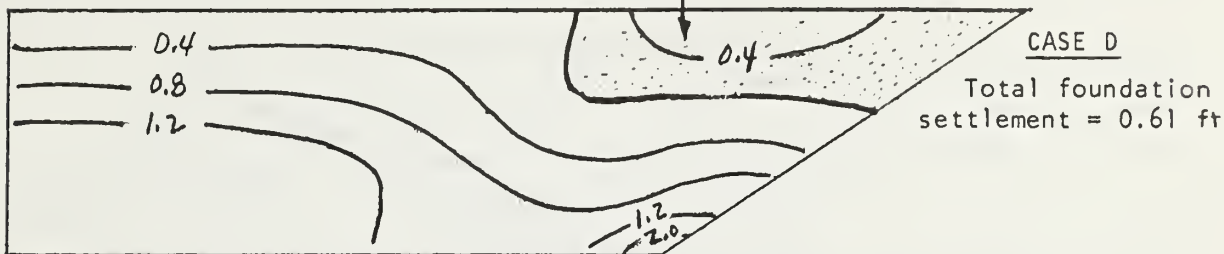
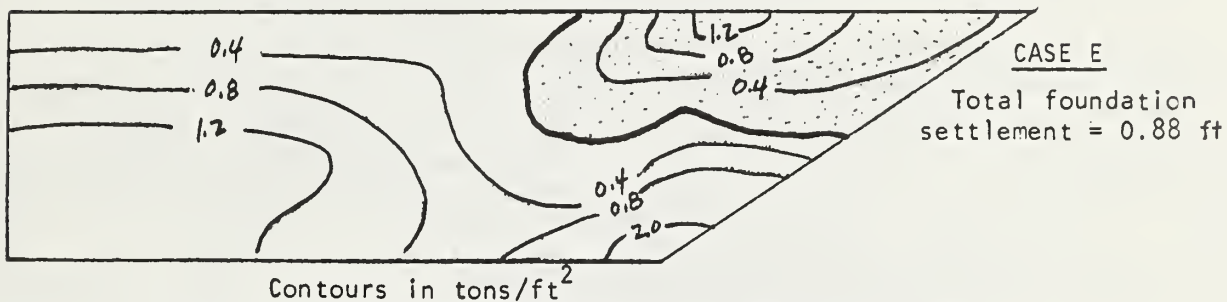
Minor Principal Stresses Computed Assuming the Foundation Settles
0.34 Feet During Construction and Continues to Settle After
Construction Varying Amounts

Sketch G-5 shows the results of calculations of the minor principal stress at every point within the embankment, computed assuming that the foundation settled a maximum of 0.34 feet during construction and then that the foundation settlement increased by various amounts after construction.

3. For foundation settlement of 1.42 feet (of which 0.34 feet occurs during construction) computations show a large zone of tension -- extending almost to the bottom of the embankment (Case G, Sketch G-5).

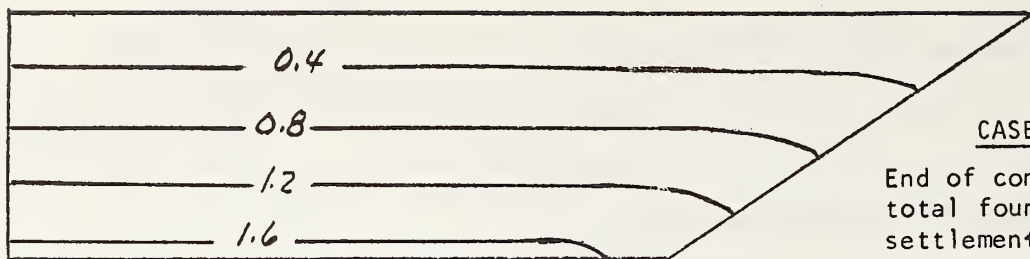
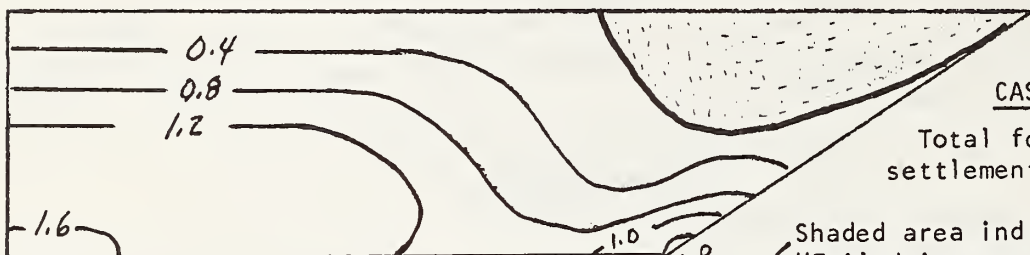
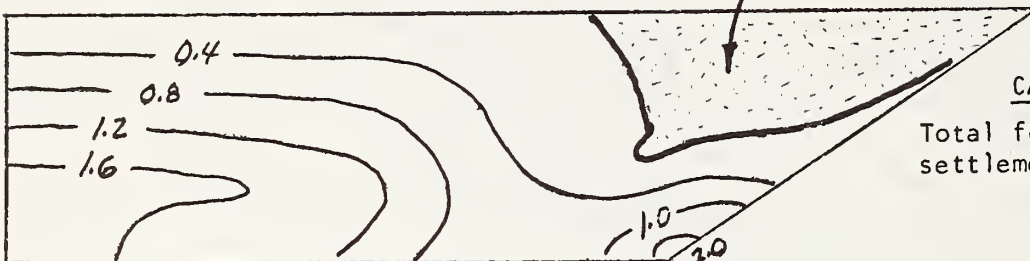
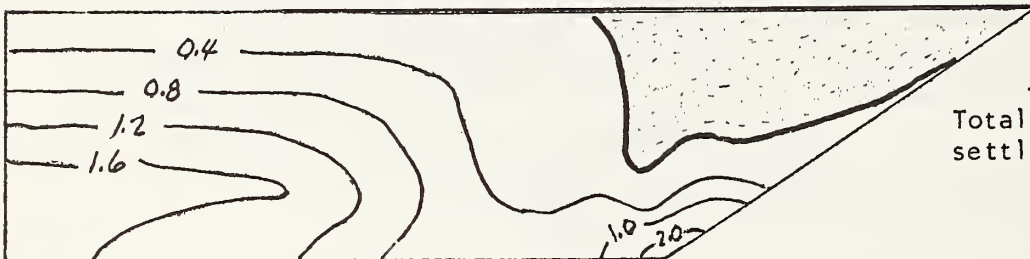
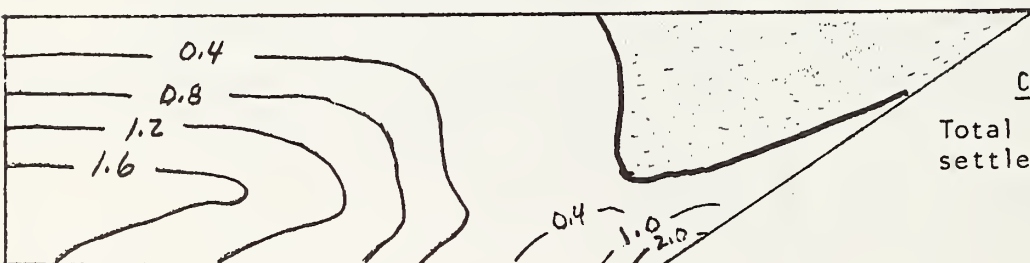
Minor Principal Stresses Computed in Same Way as Sketch G-5 Except
for Assumption That Embankment Cannot Develop Tensile Stress

The calculations summarized in Sketch G-6 are made on the assumption that when the minor principal stress enters tension, failure occurs; that is, that the minimum value of the minor principal stress is 0. The shaded areas on Sketch G-6 are those in which "tensile failure" occurs under this assumption.

4. Computations based on the assumption that the embankment cannot take tension show a "failed" zone which is roughly the same dimensions and location as the zone of tension computed on the assumption that the embankment can take tension (Sketch G-6).

Shaded area indicates
"Failed in tension"

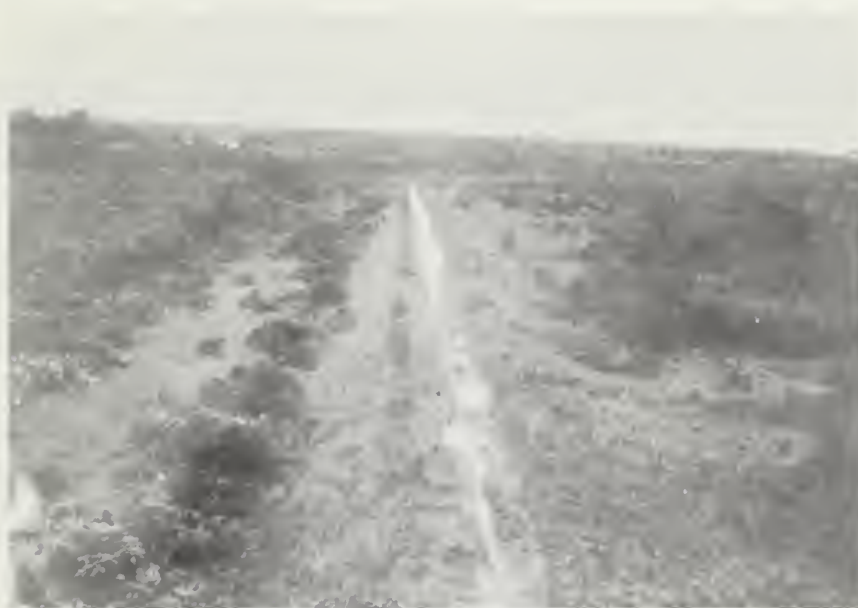
Photo 1: General view of dike from helicopter.

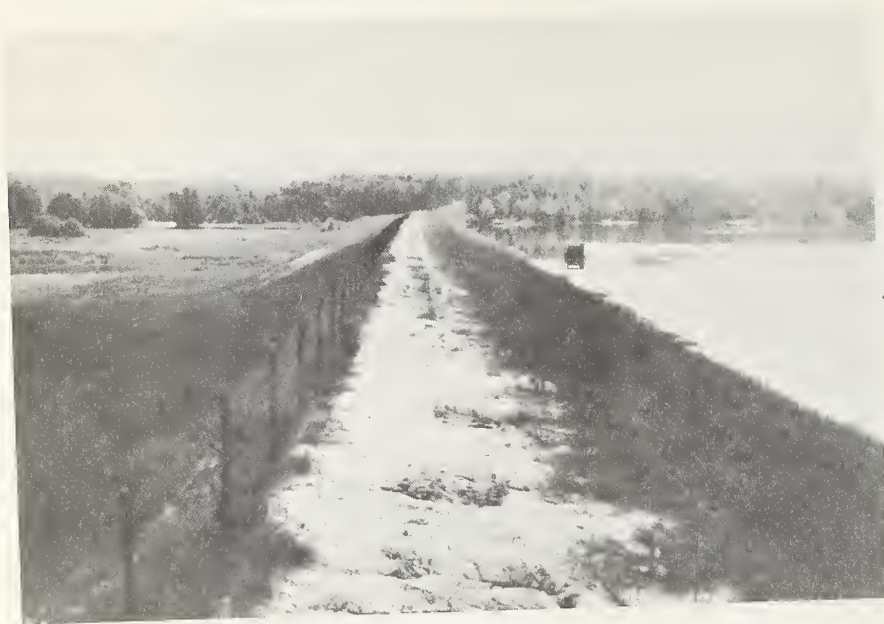
Photo 3: General view of crest showing erosion tunnels.

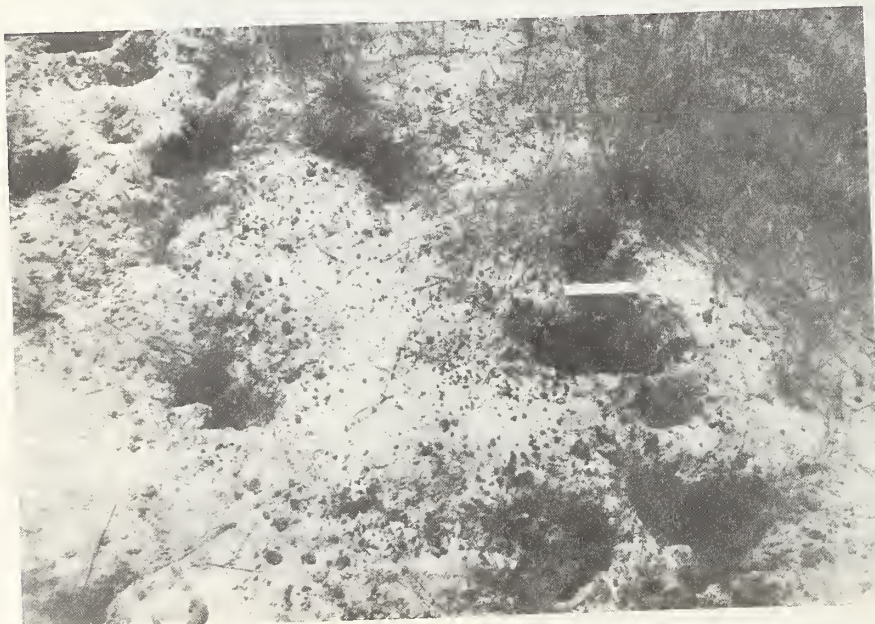
Photo 4: Group of vertical erosion tunnels on crest, averaging about 9 inches diameter.

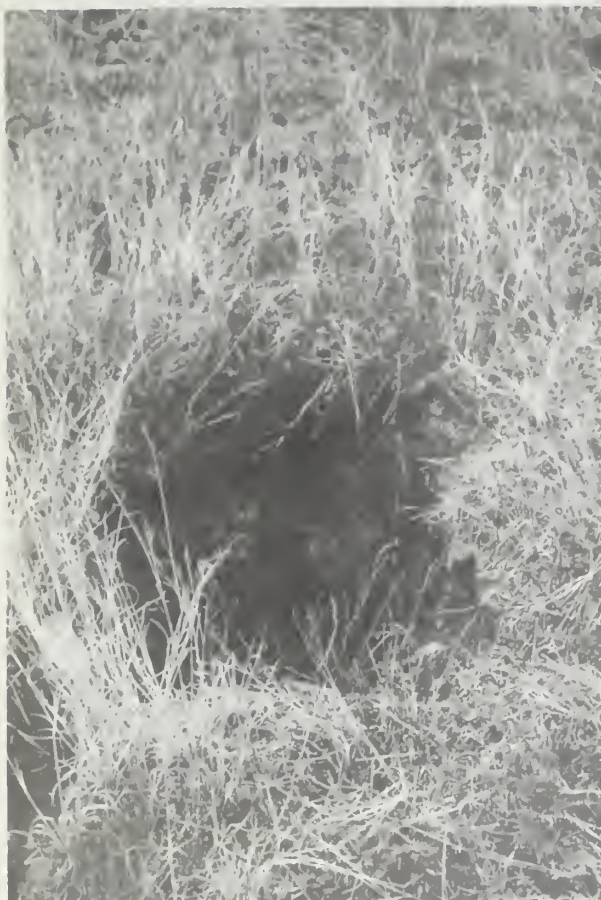
most badly damaged by surface erosion from rainfall (see Photos 3, 4 and 5, Appendix J). It is planned to repair this dam in 1971 by covering the slopes with a layer of gravelly soil, probably at a cost of the order of \$75,000. In connection with studies of the repairs of this dam a number of samples were taken from the embankment and tested prior to the present investigation (Lincoln SCS, 1971). The dispersion tests results ranged between 13 and 24% in contrast to the values of 86 to 95% obtained in the current investigation (Samples S-87 through S-89). There is little doubt that the soil types tested in the two programs were the same, on the average, for practical purposes; therefore, there is apparently something in the sampling-testing procedure which is causing large differences in the dispersion test results for these soil samples.

Photo 5: Big Sand Creek Site 8 Dam. Showing typical erosion tunnel on upper part of downstream slope. About 24 in. diameter. Note good grass protection on slope.

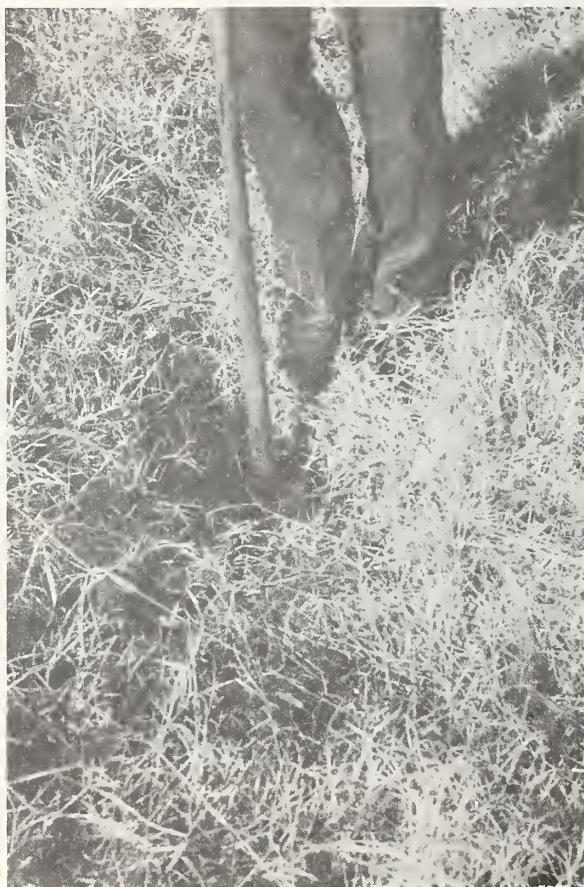
Photo 8: Wister Dam, Oklahoma. Typical, 18 in. diameter erosion tunnel on downstream slope. Excellent grass cover doesn't prevent tunnel erosion.

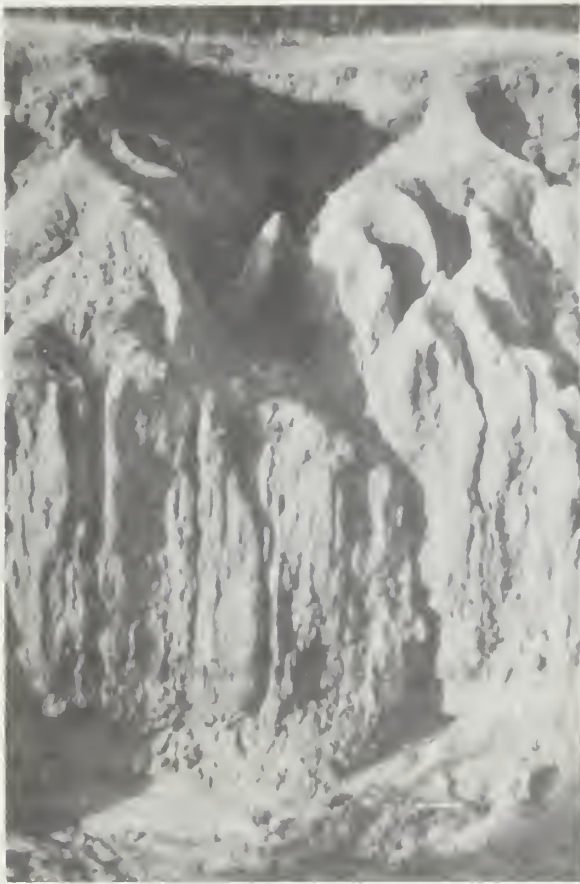
Another graphic indication of the unusual nature of these soils is the appearance of the erosion pattern which develops in excavated slopes through natural soil formations. As seen in Photos 9 through 12, erosion in these soils creates a condition which is wholly unlike the results of erosion developing in ordinary clayey soils. Very deep narrow channels and tunnels are formed which can only be explained by the peculiar combination of high erodibility and cohesion. As shown in Photo 12, particularly, the erosion pattern in some natural soils resembles very much the appearance of solution channels in soft soluble rocks, except that the process takes place much more rapidly. Even in theory, the suspension of the individual small dispersive clay particles in water is very like the process of dissolving a soluble material, since the clay particle goes into suspension and may have no tendency to settle out of suspension.

Photo 9: Typical views of erosion in excavated slope of natural soil in area of highly dispersive soils in vicinity of breached Oklahoma Dams.

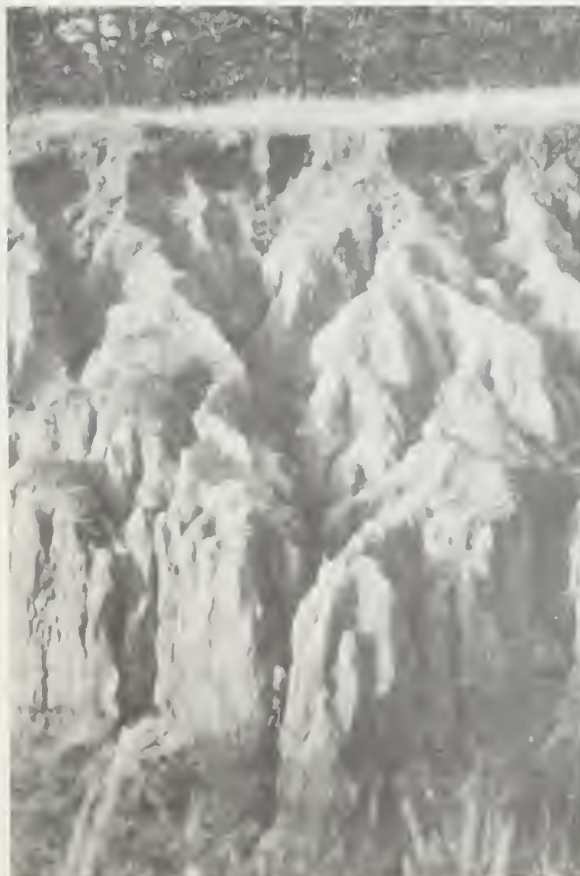
Photo 10: Note similarity to Mississippi erosion, Photos 11 and 12.

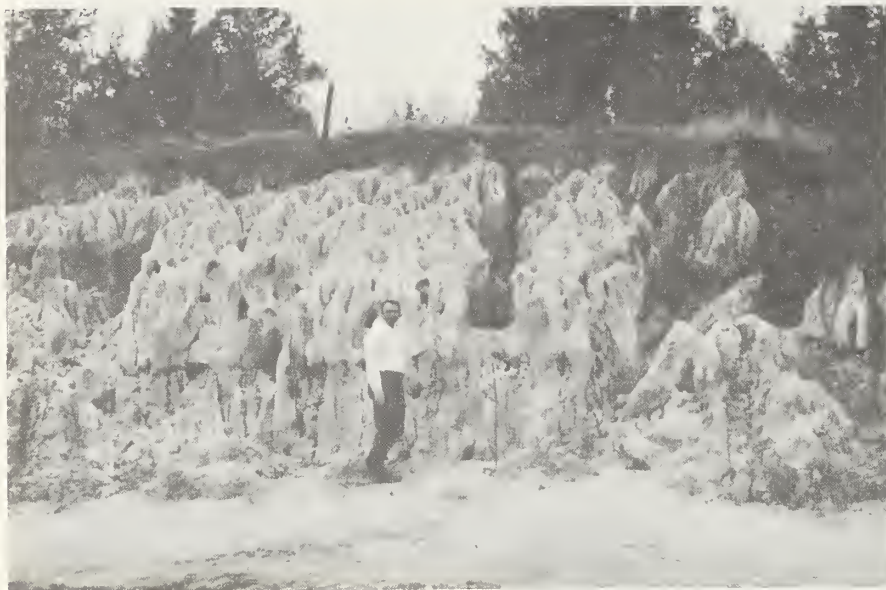
Photo 11

Typical view of erosion pattern in excavated slope in area of highly dispersive clay in Mississippi. Note alluvial "fan" of sand at bottom.

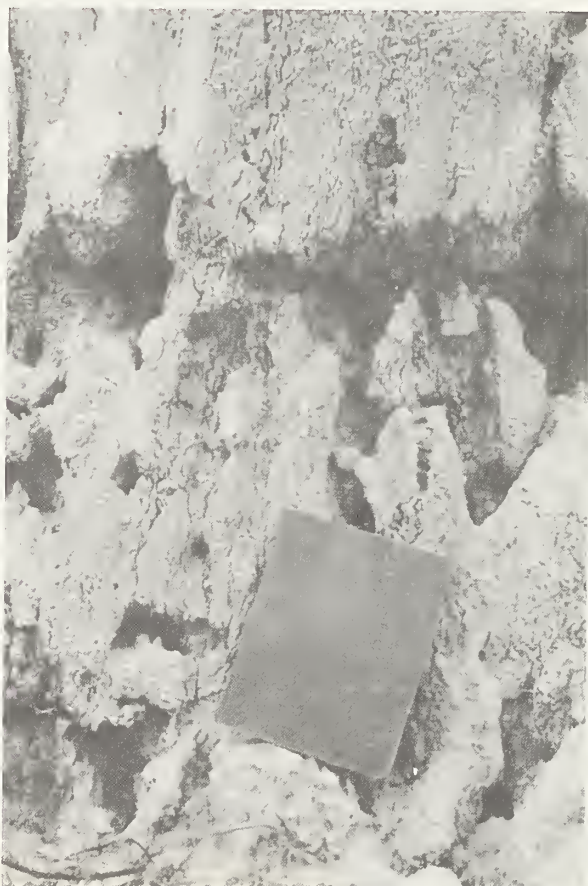
Photo 12: Closeup view of eroded face of Photo 11. Note internal tunnelling in clay deposit resembles limestone solution caverns.

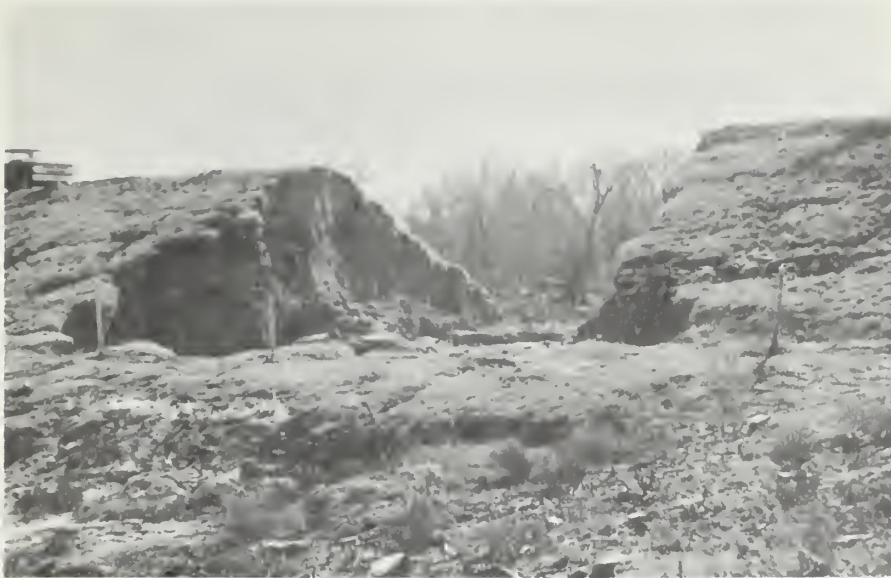
Photo 13

Looking downstream at breach (see also Sketch F-11)

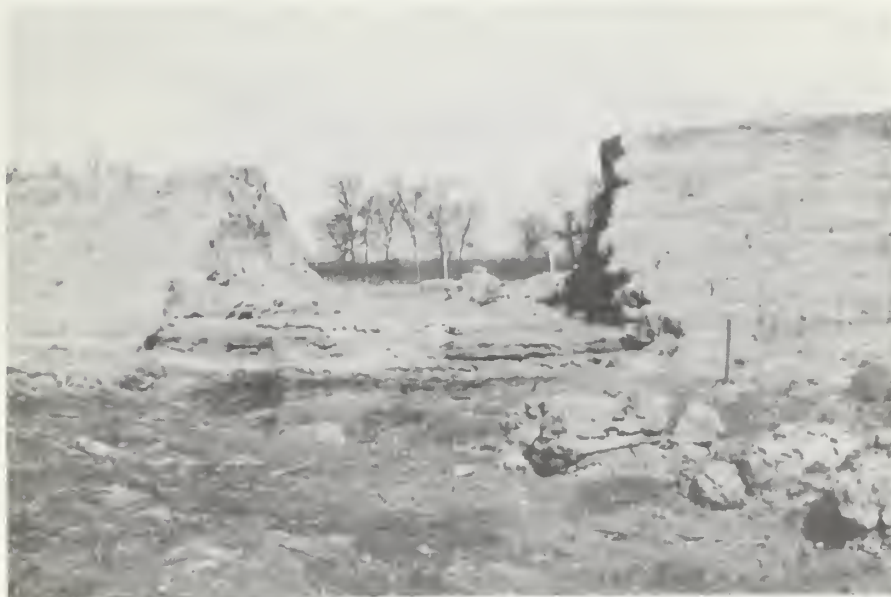
Photo 14

Looking upstream at breach

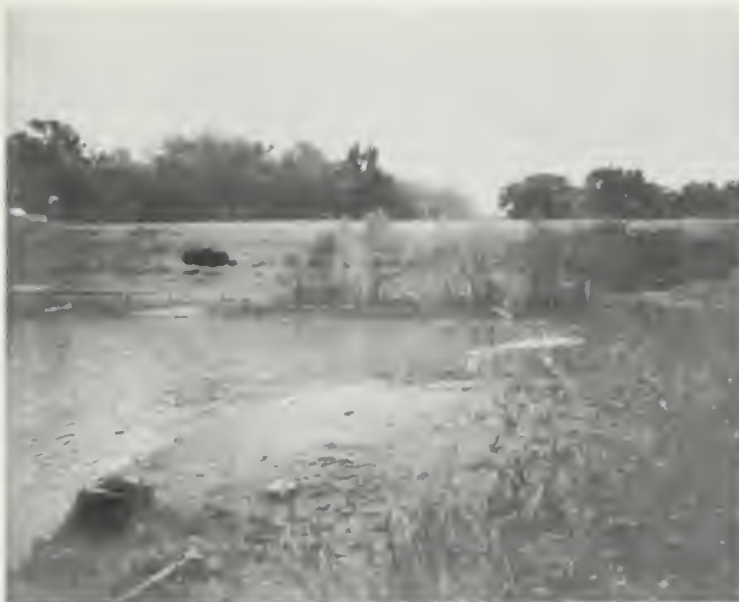
Photo 17

Looking downstream at the entrances of two piping tunnels in the upstream slope

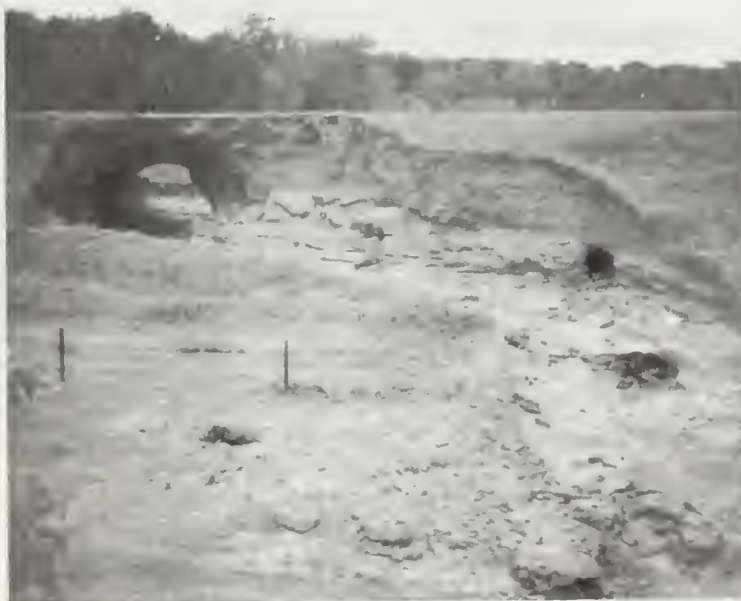
Photo 18

Looking upstream at tunnel exits.

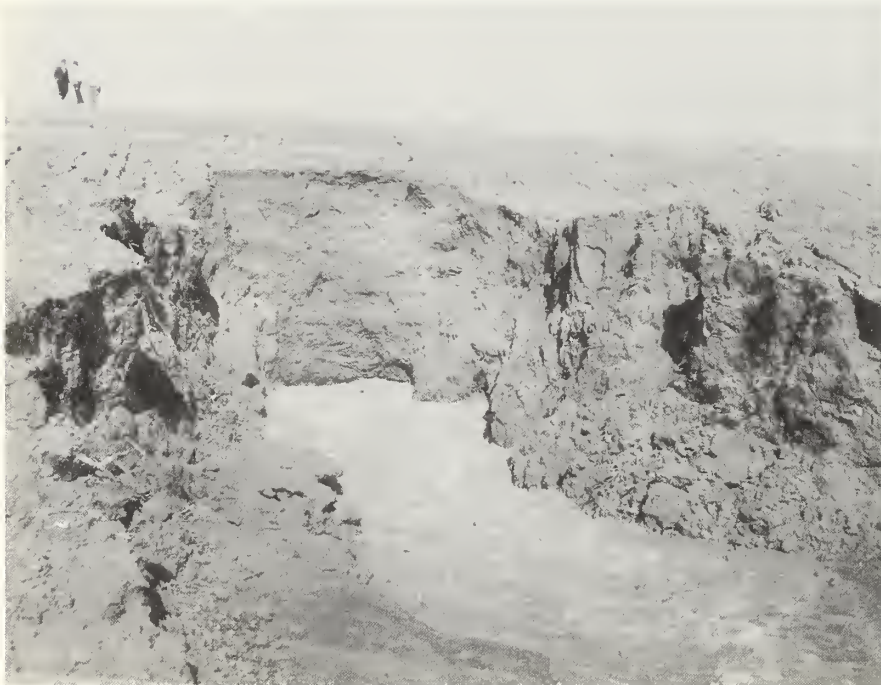
Photo 20

Nov. 20, 1964
10:15 a.m.

Caney Coon Creek Site 2 Dam, Oklahoma. Main erosion tunnel at the right abutment 24 hours after the first small leak was observed.
